**PURDY (STUMP POND) DAM**

NDI No. PA 00063

**PHASE I INSPECTION REPORT**

**NATIONAL DAM INSPECTION PROGRAM**

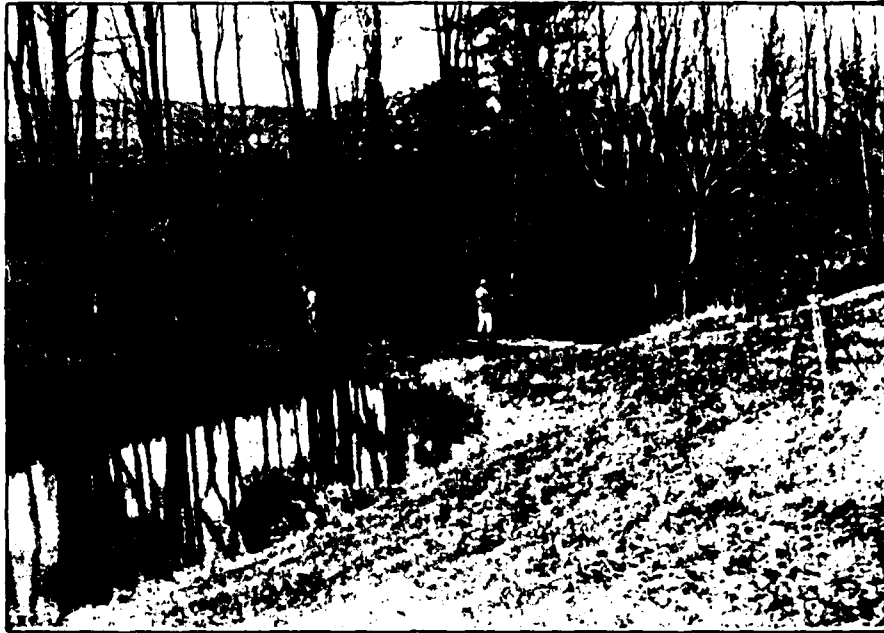
**PHOTO 1. View of Upstream Side of Dam from Right Shoreline**

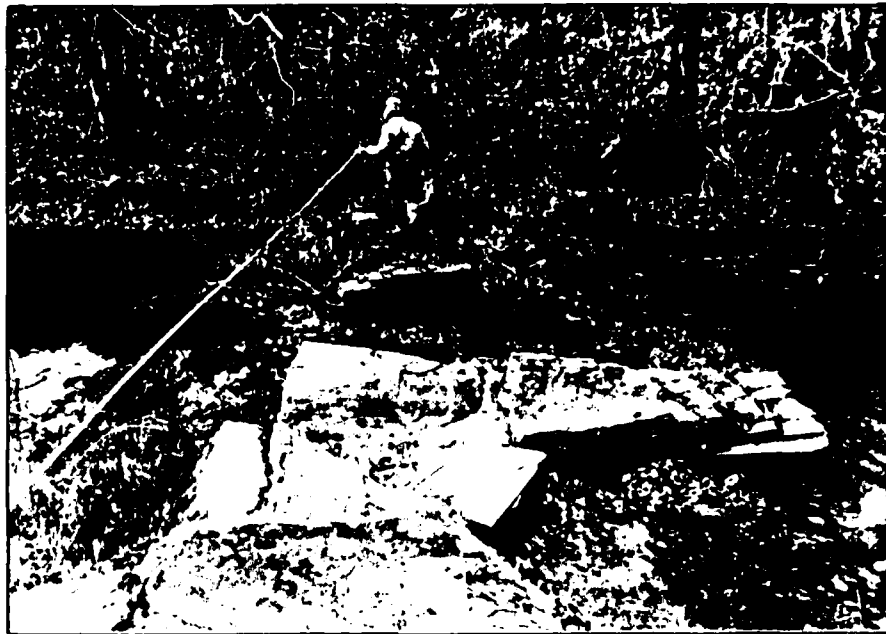
PHOTO 3. View Across Crest of Dam from Right Abutment
